Carburized Ethylene Pyrolysis Tubes – An Analysis of the
Relationship between Microstructure, Creep Performance, and
Magnetic Response

A thesis

DOCTOR OF PHILOSOPHY IN MECHANICAL ENGINEERING
IN THE
UNIVERSITY OF CANTERBURY

AMY CHARLOTTE MCLEOD

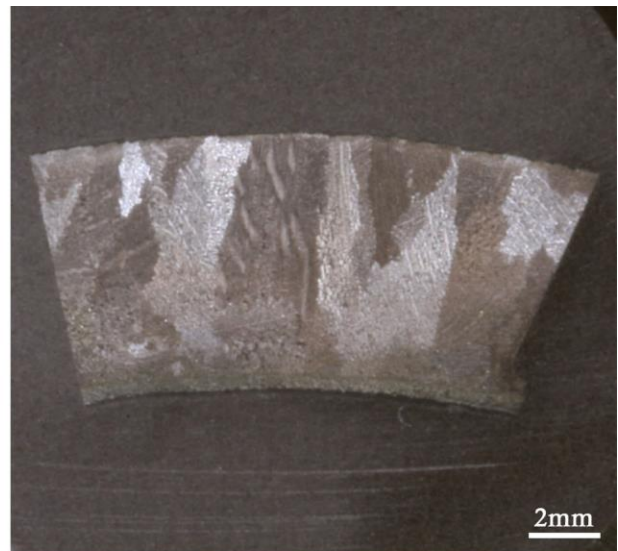
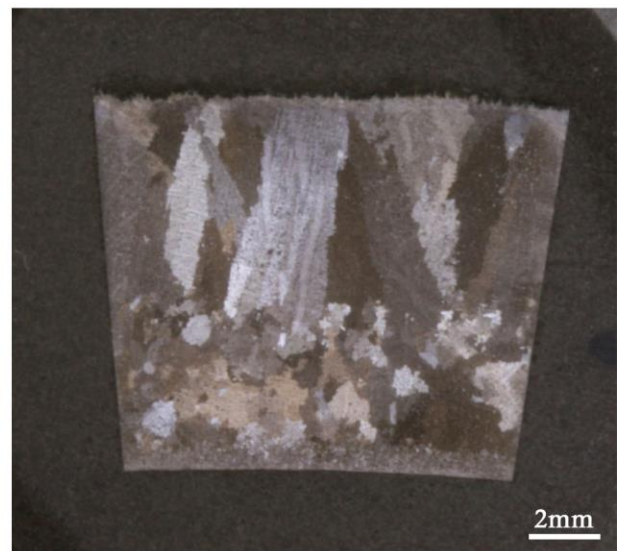
Figure 4.1 - Low magnification images showing the macrostructure of (a) tube 1, (b) tube 2, (c) tube 3, (d) tube 4, (e) tube 5, and (f) tube 6.

Samples from each of the six tubes were etched in accordance with the macro-etching procedures described in Section 3.2.3, in order to observe the tube grain structures. Figure 4.1 presents the macroscopic grain structures of each of the six tubes. Depending on the cooling rate after centrifugal casting, ethylene pyrolysis tubes can exhibit either a completely columnar or a mixed equiaxed-columnar grain structure [8, 13]. High cooling rates during centrifugal casting has resulted in 100% columnar grain structures in tubes 1-5. Tube 6 displays approximately 40% equiaxed grains (inner diameter) and 60% columnar grains (outer diameter), indicating lower cooling rates were achieved during casting in comparison to tubes 1-5.

Qualitatively, tube 1 has the largest columnar grain size; however, it was not possible to take quantitative measurements of the grain size of the tubes from the images shown in Figure 4.1. The number of visible grains was seen to be dependent on the manner in which the samples were illuminated, and grains not visible in the image would typically appear to merge with an adjacent grain, therefore increasing the apparent grain size. Changing the illumination conditions, for example the illumination angle, the light source, or the number of light sources, would typically reveal previously unseen grains, but would also result in merging other grains that were previously visible. Although the images in Figure 4.1 show a significant number of the grains that were present in each sample, not all grains were able to be captured, and therefore it was considered inaccurate to measure grain size from the macro-etched samples. EBSD mapping in order to determine grain size was considered impractical due to the large grain sized observed in the samples.

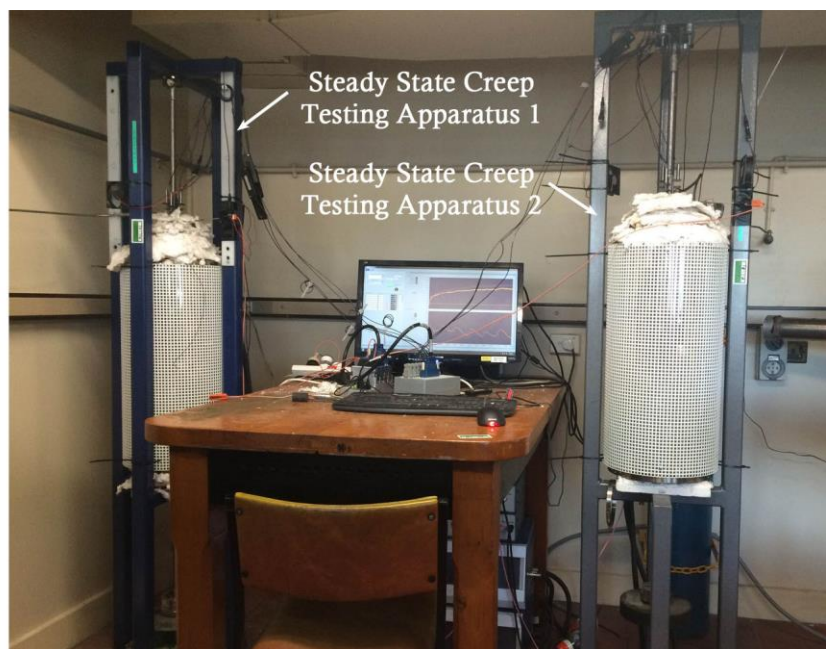
Figure 6.8 - Steady state creep testing apparatuses.

Testing of the creep samples was carried out using the apparatus shown in Figure 6.8. Set-up and operation of each creep test was conducted in accordance with ASTM E319 – Standard Test Methods for Conducting Creep, Creep Rupture, and Stress Rupture Tests of Metallic Materials [3]. The two creep testing apparatuses had both been previously constructed at the University of Canterbury for the purposes of steady state creep testing. Each apparatus enabled simultaneous testing of up to four creep samples in series. The creep sample and grip assemblies for the two apparatus are shown in Figure 6.9 and Figure 6.10. Three thermocouples were used for each apparatus: one to control the furnace temperature, one to record the furnace temperature, and one to record the ambient temperature of the room. The two thermocouples located in the furnace were situated such that the temperature directly adjacent to the top sample was measured.

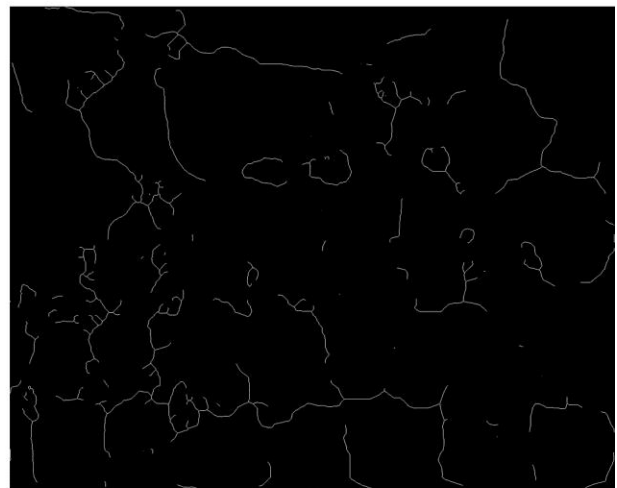
Figure 6.24 - Results of skeletonisation of M_7C_3 carbide network in a sample from tube 1. (a) Original backscattered electron micrograph, (b) thresholded and binarised micrograph with holes retained, (c) skeleton of network with holes retained, (d) thresholded and binarised micrograph with holes filled, and (e) skeleton of network with holes filled.

Skeletonisation of the primary network in carburized samples proved no easy task. Backscattered electron images initially used for the phase identification analysis were processed using the Skeletonize3D plug-in developed for FIJI [22]. The Skeletonize plug-in is essentially a binary thinning algorithm, which iteratively erodes the surface of the object until only the skeleton is left. The results of applying the Skeletonize3D plug-in to a binary representation of the M_7C_3 carbides in a highly carburized region of a tube 1 sample is shown in Figure 6.24.

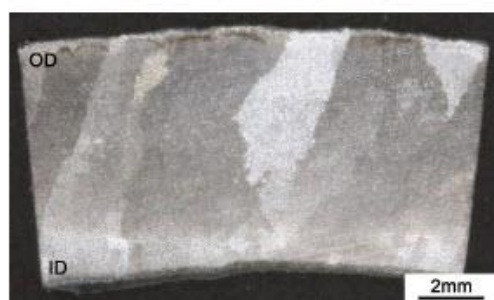
Fig. 1 Low-magnification image showing the through-wall grain structure of the ex-service tube (etchant: Marbles reagent)

Figure 1 shows the through-wall grain structure of the tube. Centrifugally cast HP alloy tubes display either a completely columnar structure or a mixed columnar-equiaxed structure, depending on the centrifugal casting conditions

(for example, the pouring temperature and the cooling rate) [13–15]. The 100% columnar structure of the ex-service tube indicates a high cooling rate induced during casting.

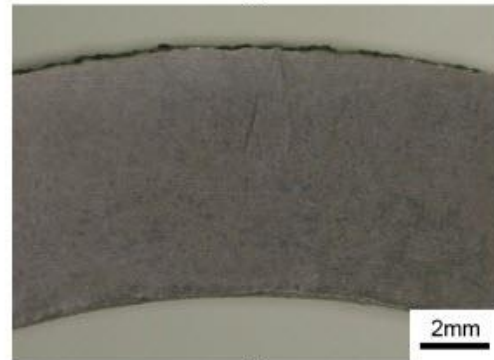
Fig. 16 Sections of (a) tube A, (b) tube B, and (c) tube C after being subjected to the NACE etching method

The etching results for tubes B and C are shown in Fig. 16(b) and (c), respectively. It was seen that tube B displayed an etching band as a result of the NACE etch, however, it was not as well-defined as that of tube A, and did not extend as far into the tube wall. The etched surface of tube C appeared dull compared to the as-polished condition but was otherwise unaffected by the NACE etchant.
